## Streetscape Audit

An important part of developing the public realm strategy has been an audit of the existing streetscape. This has involved a general assessment of the different elements in the streetscape in order to understand:

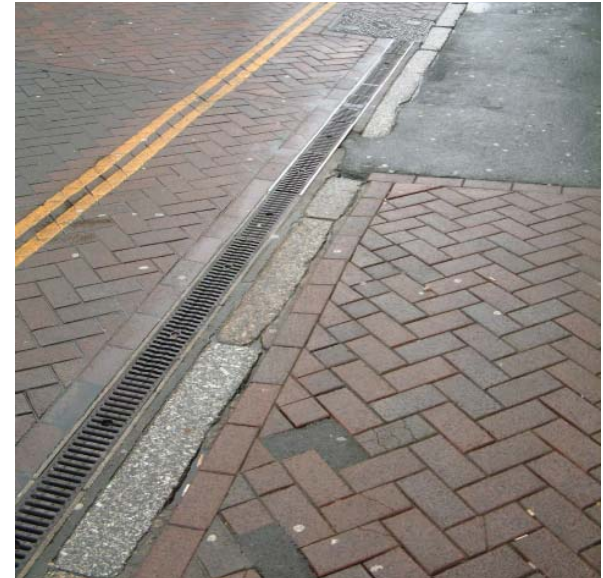
The town centre lacks any coherent structure in terms of footway paving. The existing paving comprises a palette of many materials that does not relate to each other. At many locations the footway materials have worn out or weathered unevenly and are in need of replacement. Inset covers to inspection chambers are provided at only a few places and this can result in a clutter of utility covers in the footway. The replacement of materials has often been done on an ad hoc basis with areas patched with whatever material was available.

The pedestrianised High Street area is paved with

Poor quality existing floorspace

clay pavers, granite setts and York stone and, despite it being identifiable from other areas of the town, is visually incoherent and cluttered.

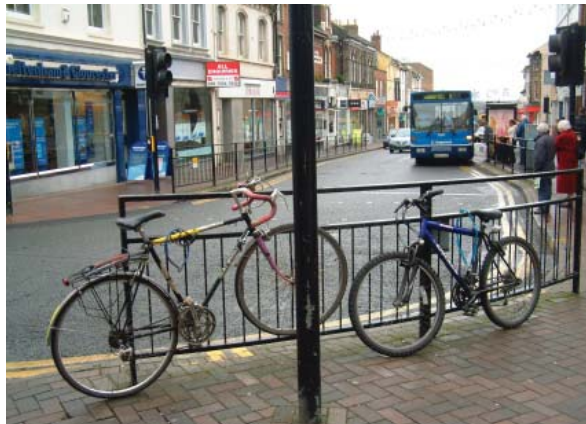
There are very few bicycle stands within the town

Opportunities for additional cycle stands

centre with these mostly concentrated in the High Street area. The choice of materials, design and location of street furniture and their coordination with larger level strategies plays an important role in raising the quality of the streetscape. It appears that little attention has been given to these issues in the past.

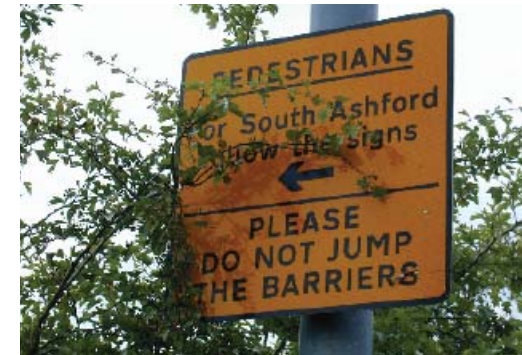
Inadequate and poorly integrated signage

Directional signage in the form of information maps and boards are located at the station. However, they do not guide visitors along routes to key areas within the town centre as no effort has been made to integrate them with the associated signage. The signage appears to be isolated indicators and this is an issue for Ashford as it is fragmented by

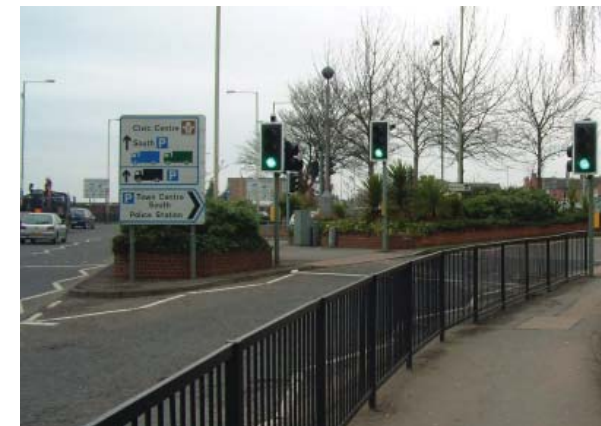
Visually dominant highway infrastructure

In general, there has been insufficient control over the number and size of traffic signs used in the town centre. Multiple signs have been clustered especially at the entrances to the ring road without consideration to how much information motorists can reasonably be expected to absorb. Standard

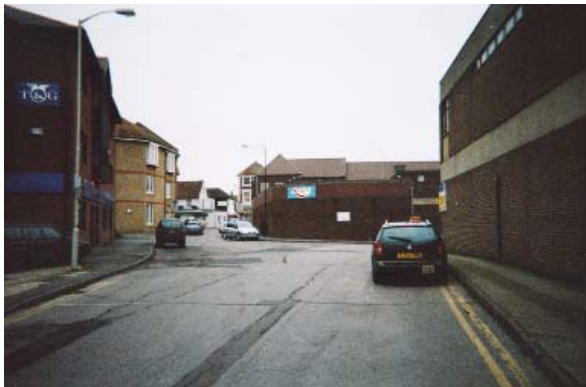
Existing blank walls and service access

Many streets have buildings that have dead walls and railings which present an unfriendly streetscape. The backs of large retail outlets and car parks in the town centre have transformed some streets into service lanes only. Private forecourts are seldom seen as part of the larger public realm framework.

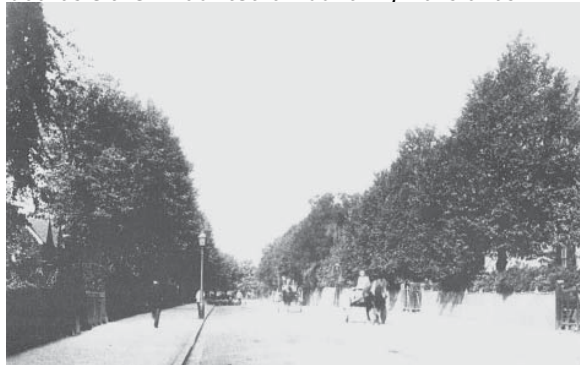
The historic lime tree lined Elwick Road

Within the town centre there is very little planting within the footways. However, a characteristic of some streets is trees planted at the edge of property lines that form a canopy to streets (Church Road, Elwick Road, Vicarage Lane). This unique quality in these streets needs to be recognised and respected in the public realm strategy.

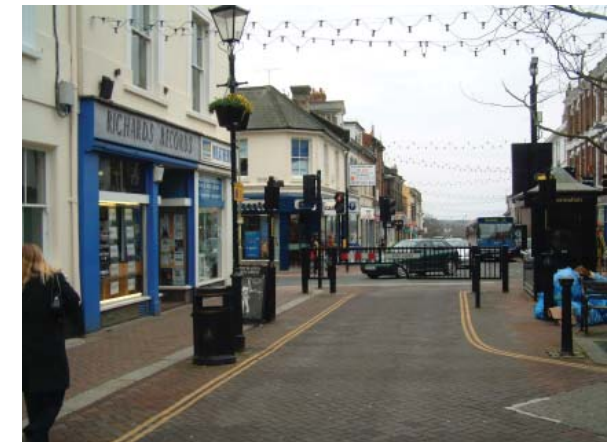
'Traditional' lighting columns and year-around 'festival' lights in Bank Street.

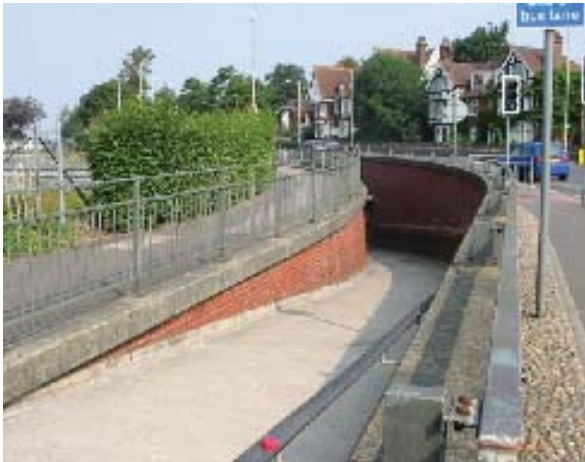
Barriers to pedestrian movement

On Elwick Road and Somerset Road there is a lack of defined street edges and uses and this has reduced these roads into high-speed vehicular routes that are unpleasant for pedestrian usage. The footways, edged at many places by high dead walls on one side and guardrails on the other, are devoid of any element of streetscape other than street lighting and traffic signs.

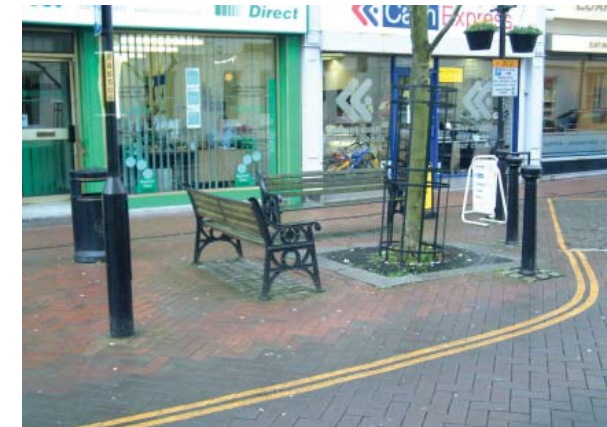
Typical arrangement of existing town centre street furniture

In contrast seating provided near the station in conjunction with a landscaped area is hardly used at all as it is completely segregated from the surrounding context. In the remainder of the town centre, the approach has been uncoordinated resulting in seating being unused and abandoned.
