**Victoria Park, Ashford**

**Conservation Plan**

**Volume 1 Text**

**July 2018**

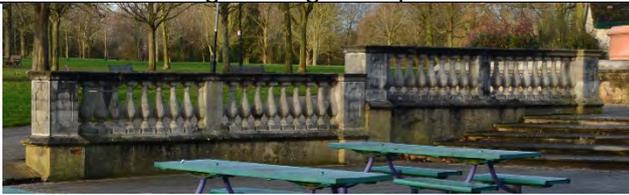
Number	<b>7</b>	Name	Balustrades
Location	Area C		
Date	1990s in present form but contain elements from 1912 and before		
Type of feature	Balustrades		
Dimensions	About 1.2m high Length as plan		
Description and history

<p>The setting created for the fountain in 1912 uses the plinth and stags</p>

associated with the fountain when it was at Olantigh House. The arrangement is shown on Figures 59-62 The design present today dates from the mid-1990s. The design of the plinths is the same as in 1912 and the originals may have been re-used. The form of the balusters is also the same. The number of steps down from the fountain was increased in the 1990s.
Sources	UDC minutes, photographs as shown in vol 2, 1992 Victoria Park Masterplan and subsequent planning applications.
Condition	Fair
Significance	H Medium/high E Medium A Low/medium CMedium
Maintenance and Management Requirements.	Regular inspection

balustrades. This arrangement replaces much narrower steps and curved balustrades present until the 1990s (Figure 56). Lines of setts and tree grilles mark the short avenue created in the 1990s that aligned with the original balustrades. The 1912 plaque on the fountain that was central to the original alignment can still be seen.

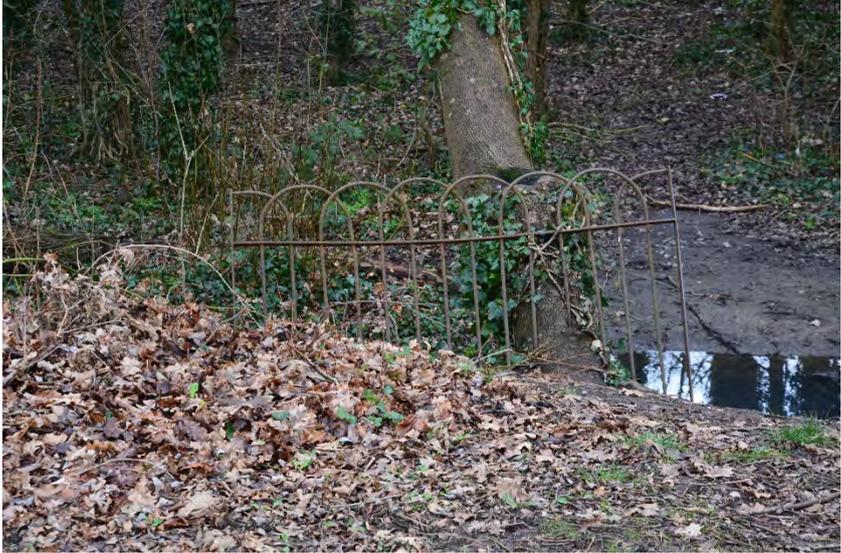
Sources	OS maps Tree survey
Condition	Moderate. Chanel overgrown and stagnant. Trees good
Significance	H Medium E Low A Medium C Medium
Maintenance and Management Requirements.	Tree inspection Open-up watercourse

- 3.9.1 **H1. Old Boundary** A watercourse arising in Watercress Fields forms the west boundary of the original park and has mature oaks along it. The watercourse itself is quite deeply shaded, but supports plants of nutrient-rich conditions like hemlock water-dropwort (*Oenanthe crocata*) as well as patches of sedges and tall herbaceous plants such as great willowherb. Beyond the watercourse there are approximately 100 closely-spaced trees consisting a mixture of ash, willow and field maple. Ivy is the main groundcover beneath the dense shade and it has also encroached into the lower crowns of the trees.

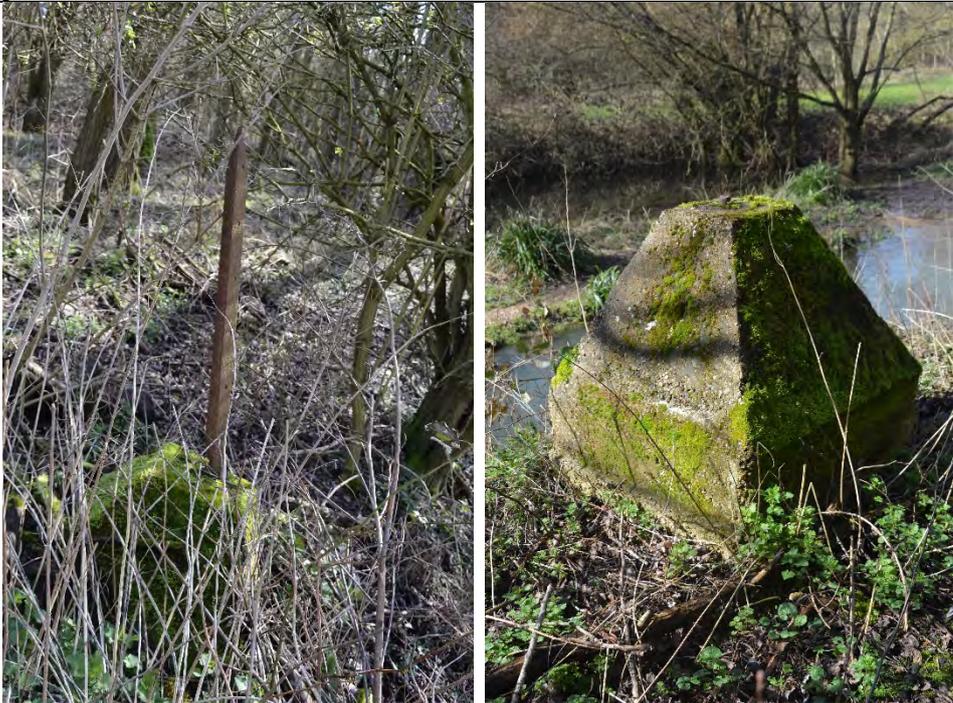
Number	<b>38</b>	Name	Second World War wires
Location	I2		
Date	1941		
Type of feature	Military		
Dimensions	Pimples 3ft high 3ft 6ins base. Angle iron in top 5ft high Line approx. 500 yds		
Description and history

<p>Line of standard concrete anti-tank pimples with angle irons set in top with holes for wires. Transcription of war diaries refers to 4 miles of wire around fortress Ashford</p>		
Sources	H R Pratt Boorman, Ashford's Progress ( 1977) has what appears to be a partial precis of the war diary for Ashford TNA WO166/6852 1May 1941- January 1943		
Condition	Poor Overgrown and collapsing into river		
Significance	H Medium E Medium/high A Low C Medium		
Maintenance and Management Requirements.	Record fully before they are lost

- 5.7 Work began on the fortress in May 1941 with deepening the river and placing pipe bombs around one and a quarter miles of the boundary.<sup>109</sup> Concrete and other anti-tank obstacles were constructed for three miles and there was an outer wire defence four and a half miles long. Canadian soldiers had completed the pipe mines by 2 July. The exact location of the fortress has not been worked out, but Dr Peter Frost describes the defences formed around the important junction of the railway and the A28 400m north of the park.<sup>110</sup> There was also a strong point at the turnpike toll house at the junction of Beaver Lane and the A28 and an anti-aircraft battery close to the railway near the gas works. Aerial photographs of September 1941 (Figure 47) show the north bank of the river opposite the park having been recently regraded. There were dense rows of anti-tank pimples along the south edge of the gas works and turning northwards across the railway to the southwest corner of the town. A corresponding row lay to the east of Gasworks Lane to protect the electricity works. There was a bank or bank and ditch parallel to the north side of the railway, together with a substantial bank heading northeast from the start of the canalised section of the river. Upstream of this there do not appear to have been any works to the river channel where the sinuous course and the steep banks form a natural defence. However, on the lip of the north bank, between the west edge of the former gasworks site and the junction of the footpath/cycleway with the path from Ford Way there are 20-30 anti-tank pimples with angle irons embedded in them (38). The angle irons are perforated for wires which would have been part of the defences.

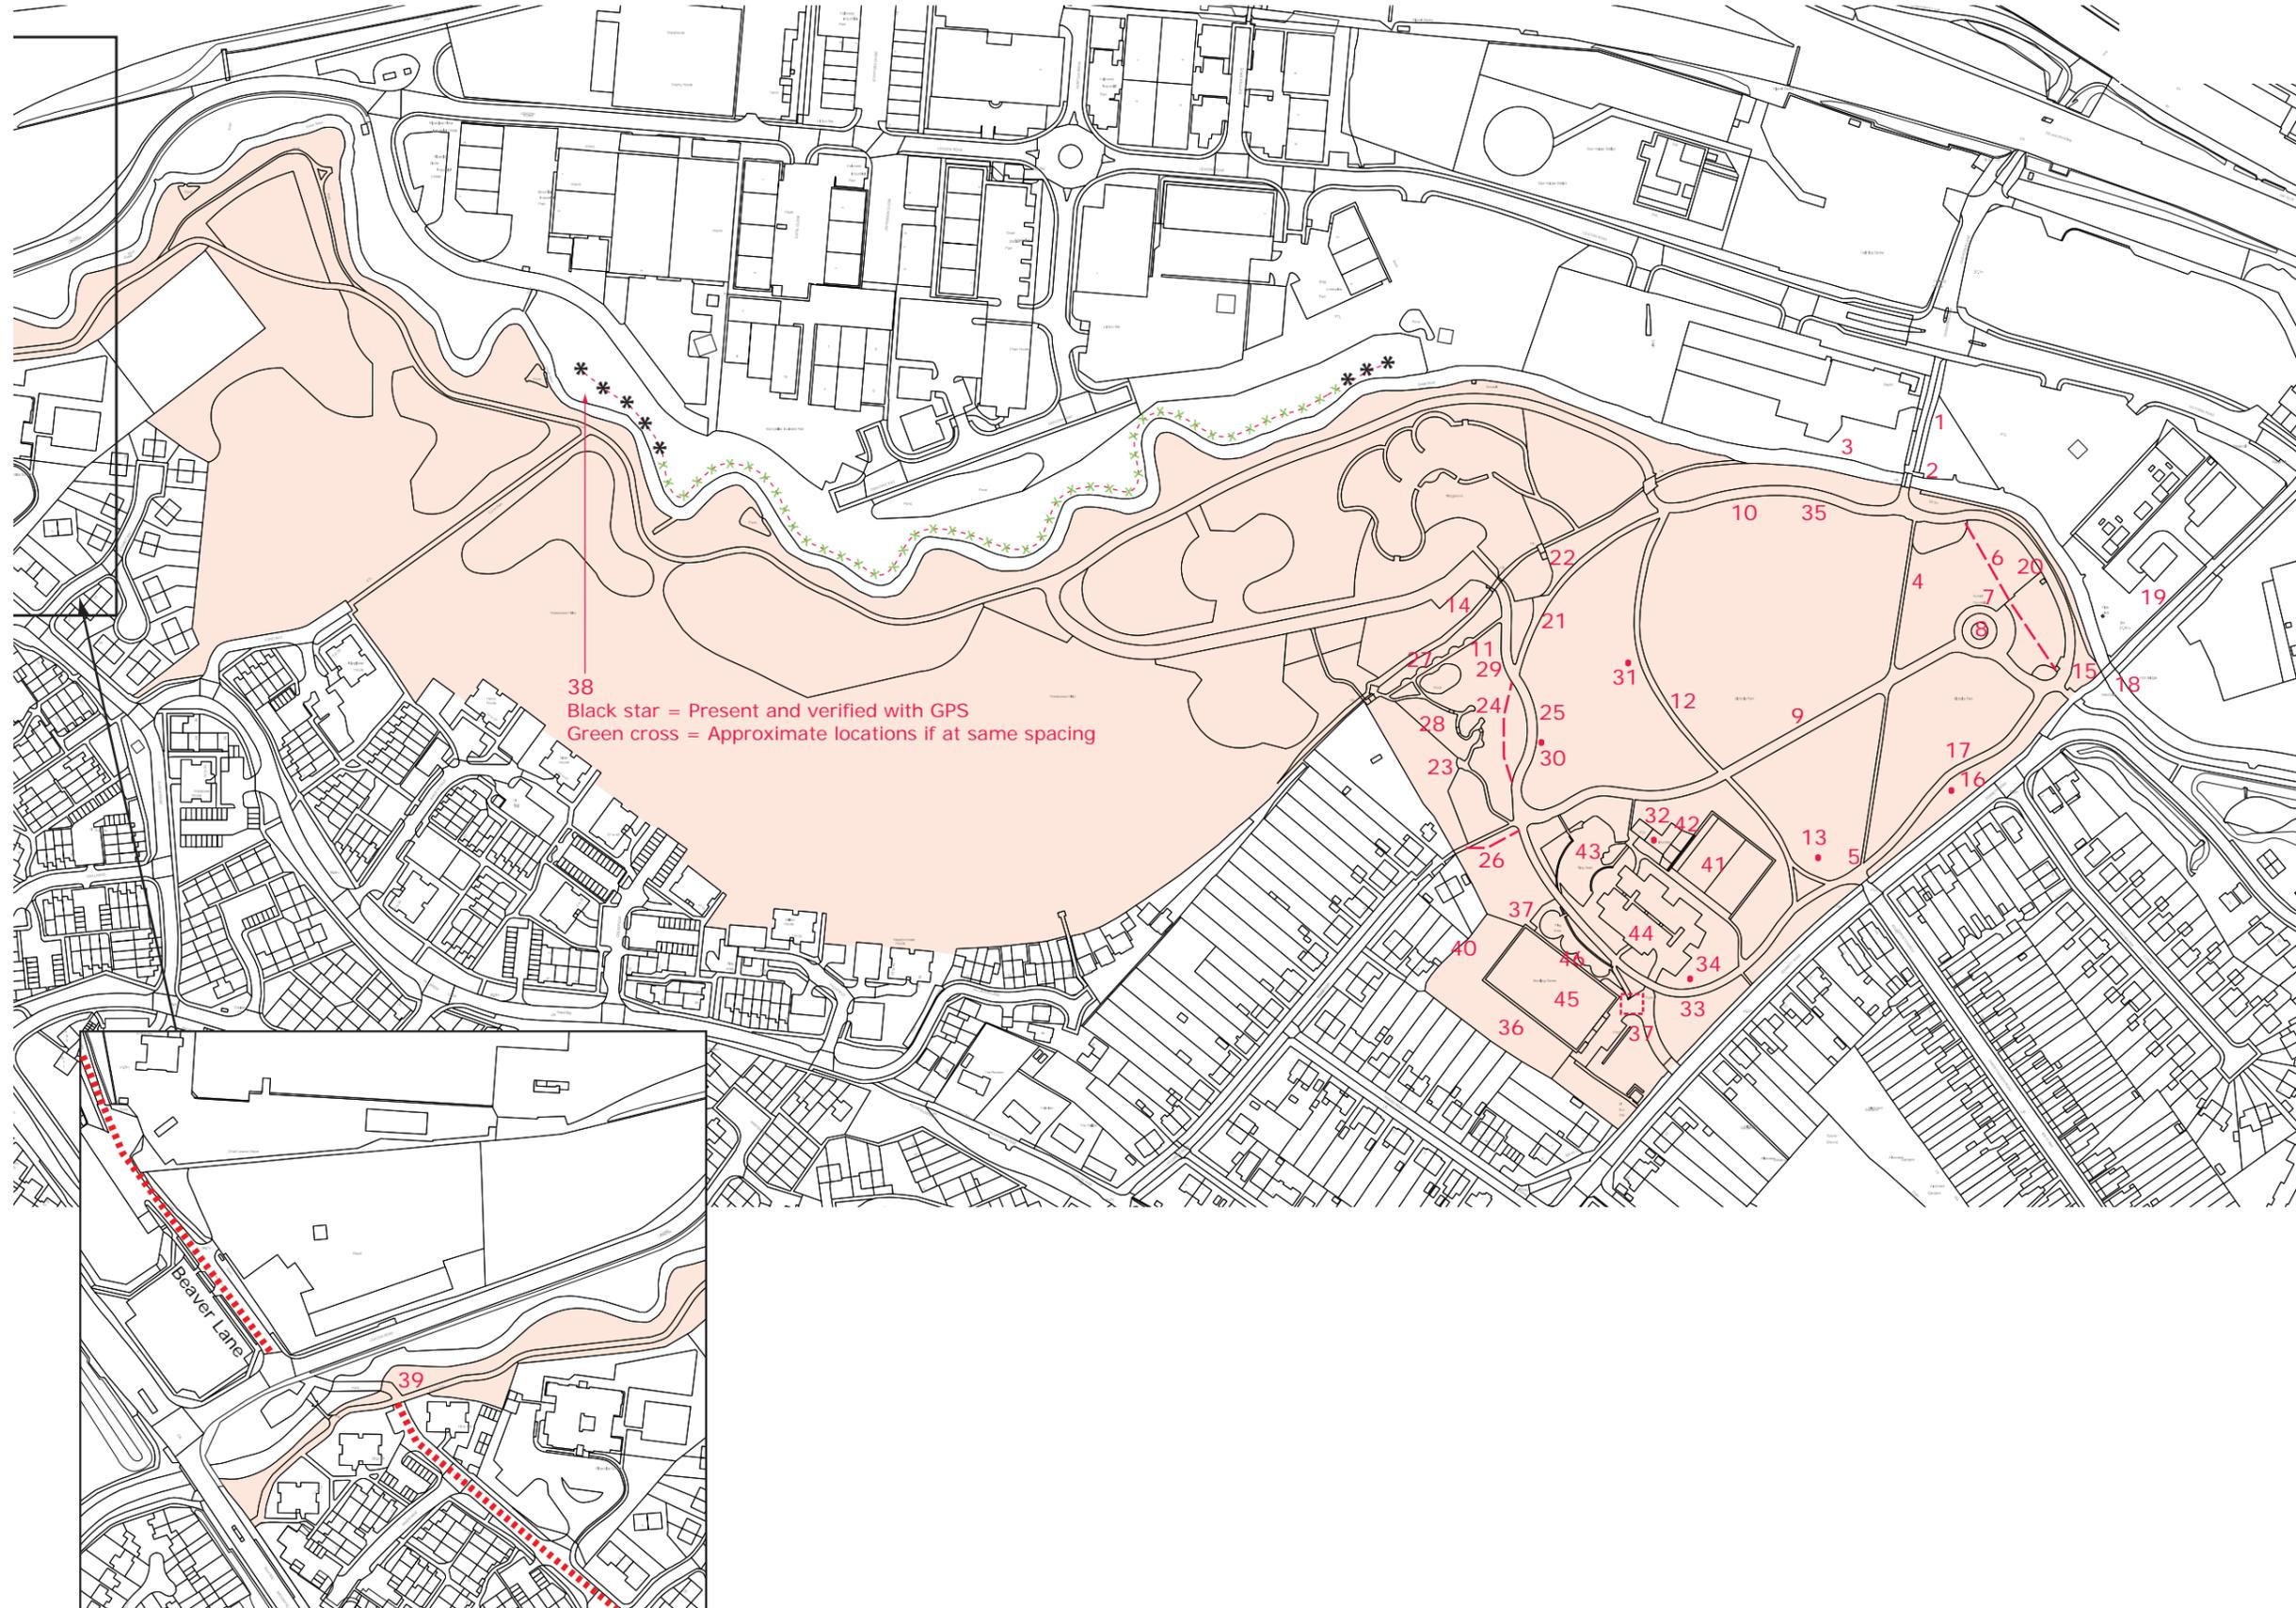
FIGURE 4: Gazetteer sites

38  
 Black star = Present and verified with GPS  
 Green cross = Approximate locations if at same spacing

19 Gazetteer site

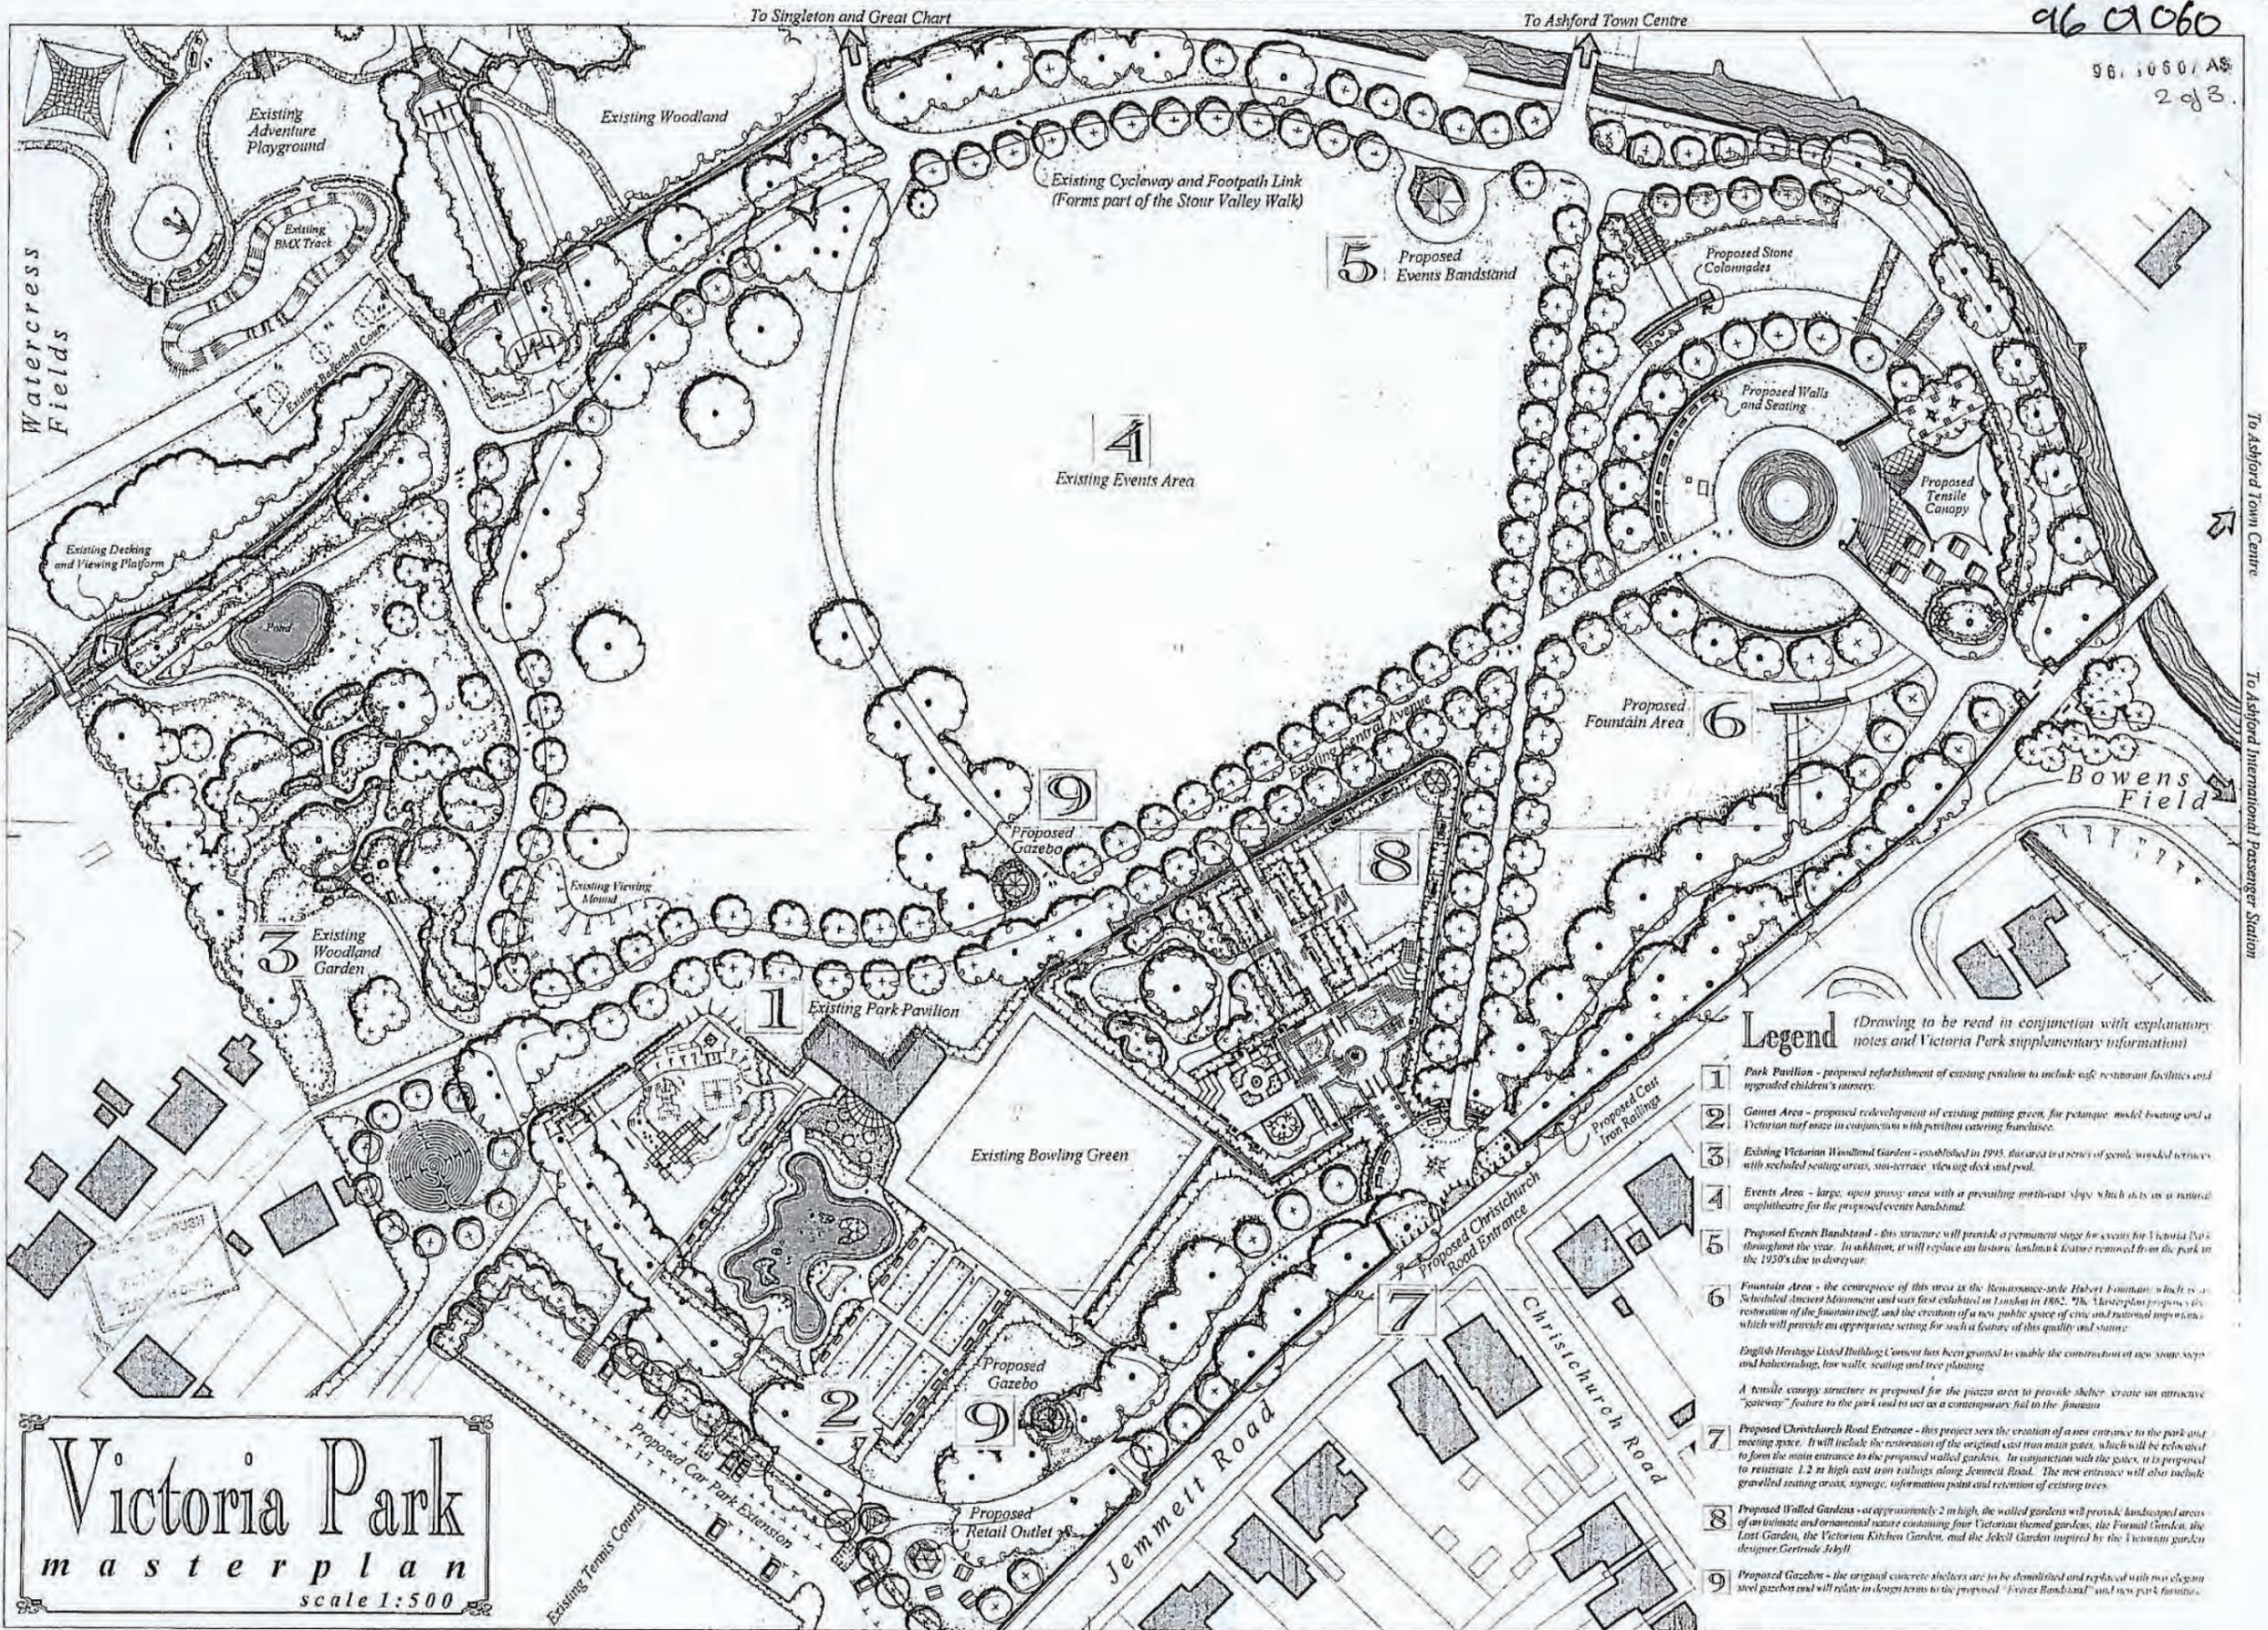
55. Proposals for Victoria Park, 1994

**Victoria Park**  
 masterplan  
 scale 1:500
